## HLH ROTOR BLADE MANUFACTURING TECHNOLOGY DEVELOPMENT REPORT

Boeing Vertol Company  
P. O. Box 16858  
Philadelphia, Penn. 19142

September 1977

Final Report

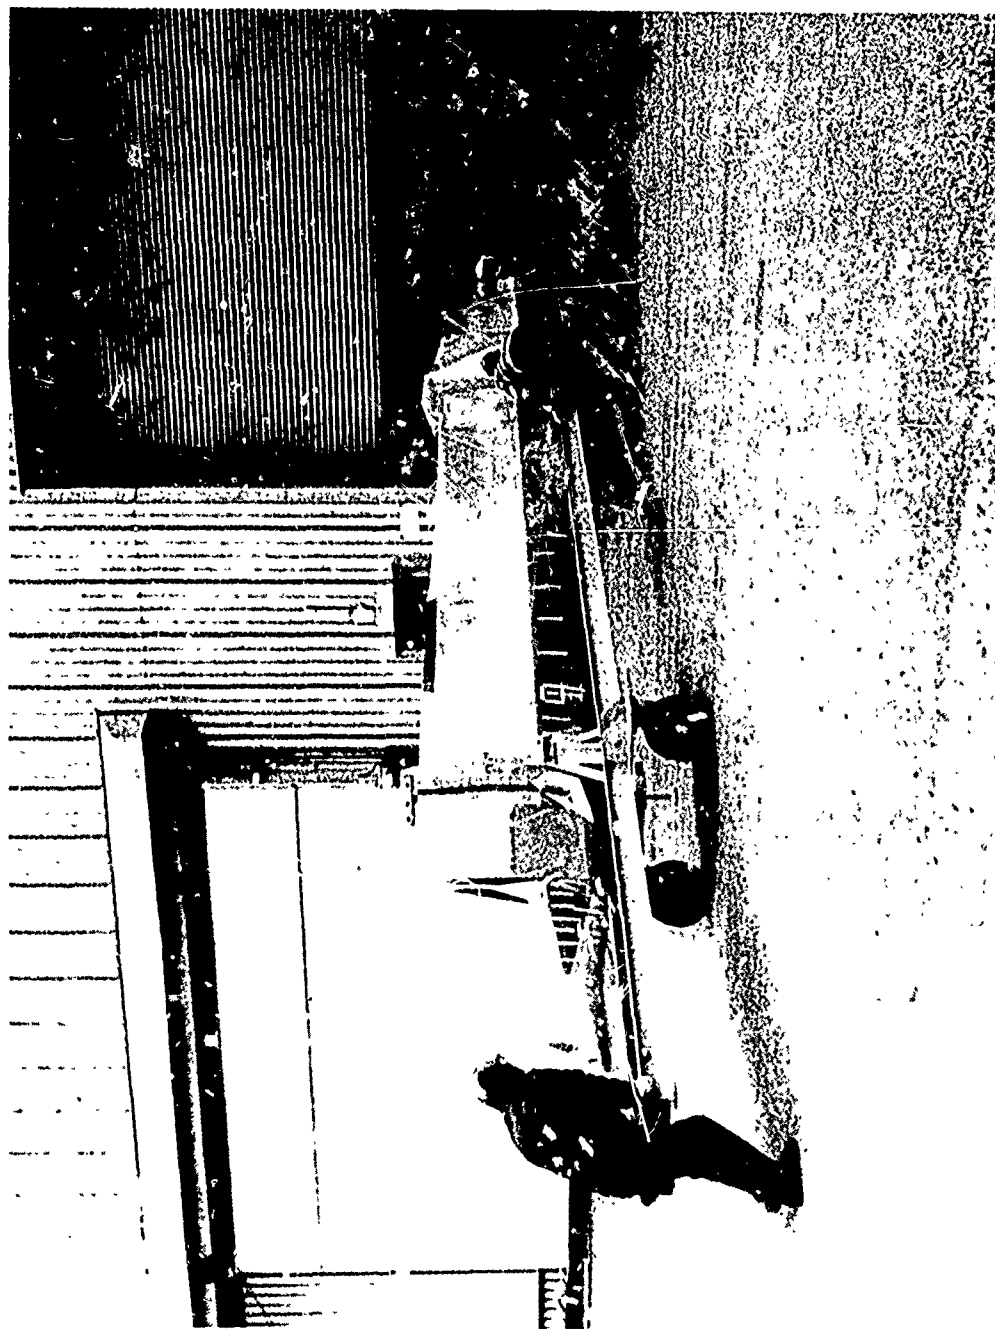
Figure 67. Transporting Blade No. 3 to Instrumentation Laboratory

A special dolly (FME SK301-11171, Figure 67) was also fabricated for interplant movement of completed blades.

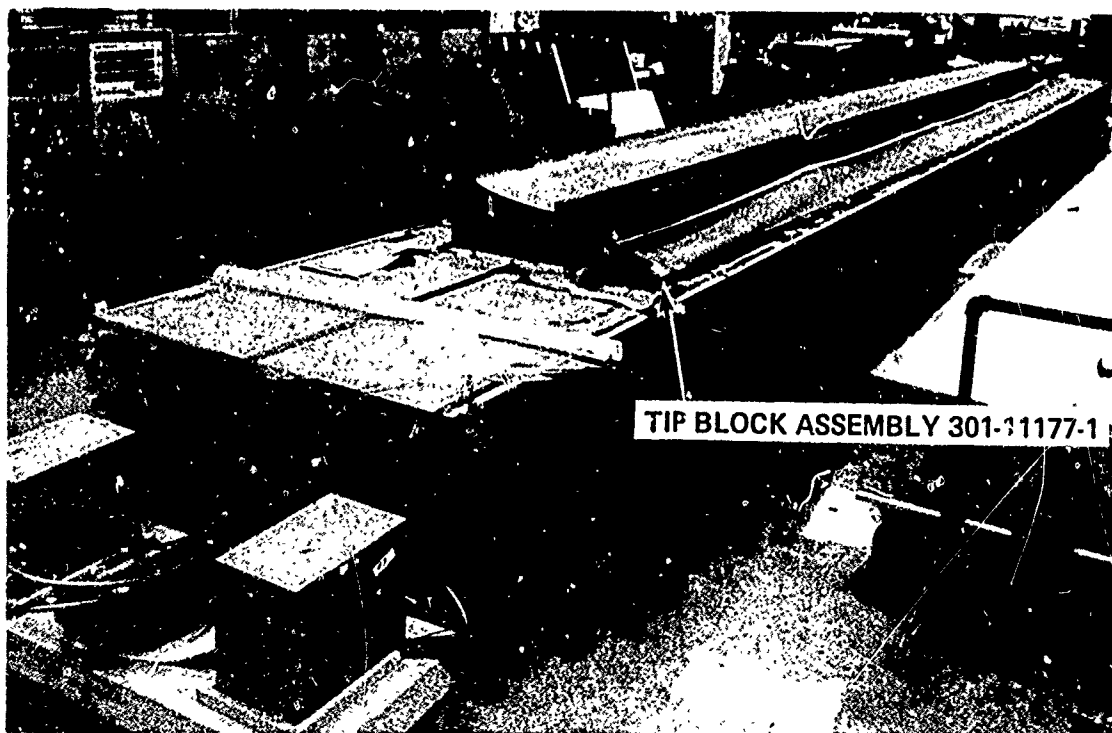
*Figure 69. Leading Edge No. 1, Showing Tip Block Cured in Place*

To simplify the spar assembly task, the down stage leading edge subassembly was created (Figure 69). Included in this subassembly are the titanium leading edge and simulated heater blanket, the nose block detail, and the tip block subassembly. Fabrication involved assembling the compacted glass blocks (tip and nose) with the titanium cap and the heater subassembly. With a mandrel for internal pressure, the part was cured in the spar bonding fixture. After the cured part was unloaded and the mandrel removed, a trim operation was performed, and excess resin and peel ply were removed.

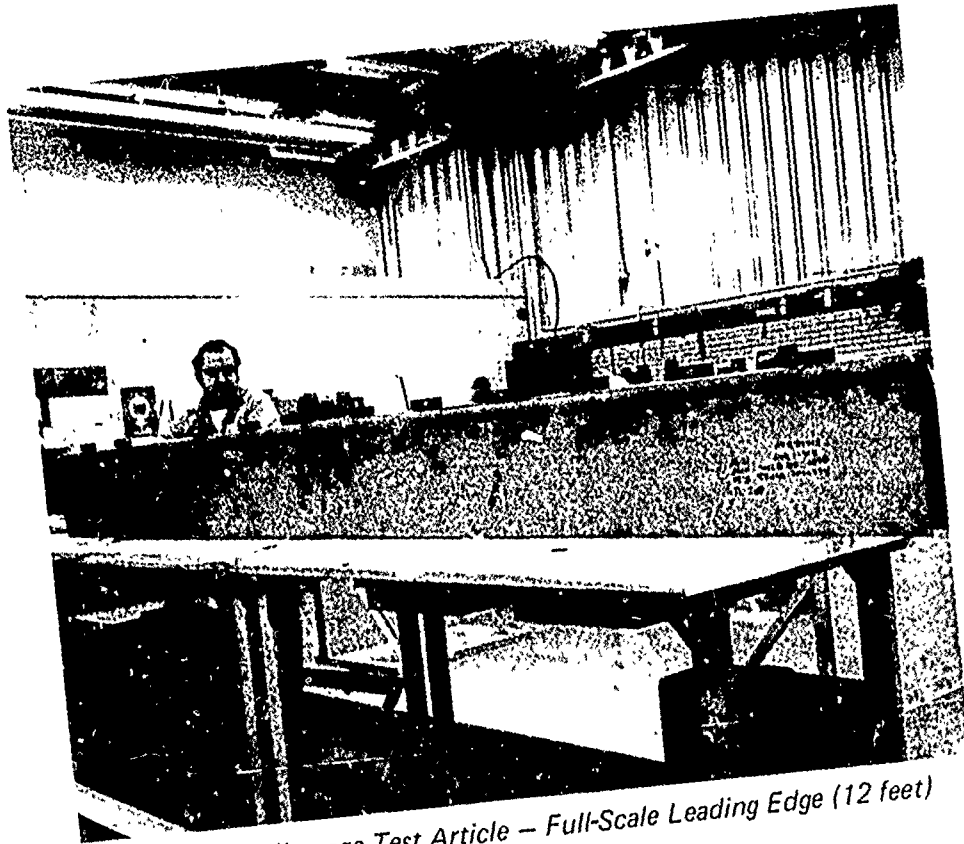
Figure 70. Warpage Test Article - Full-Scale Leading Edge (12 feet)

There was a major concern in the preplanning stage that the different thermal coefficients of expansion of the titanium and glass materials would cause a warpage problem with this subassembly. A series of meetings were held to identify methods of optimizing the tooling to minimize this condition. It was concluded that a warpage test specimen would be run to fully understand the problem prior to fabrication of the full scale spar. The specimen was 12 feet long, with a nose block and titanium leading edge, and was built to simulate the actual fabrication sequence. (Refer to Figures 70 and 71). Based on test results of that specimen and the tool concept utilized, it was determined that warpage was not a problem.

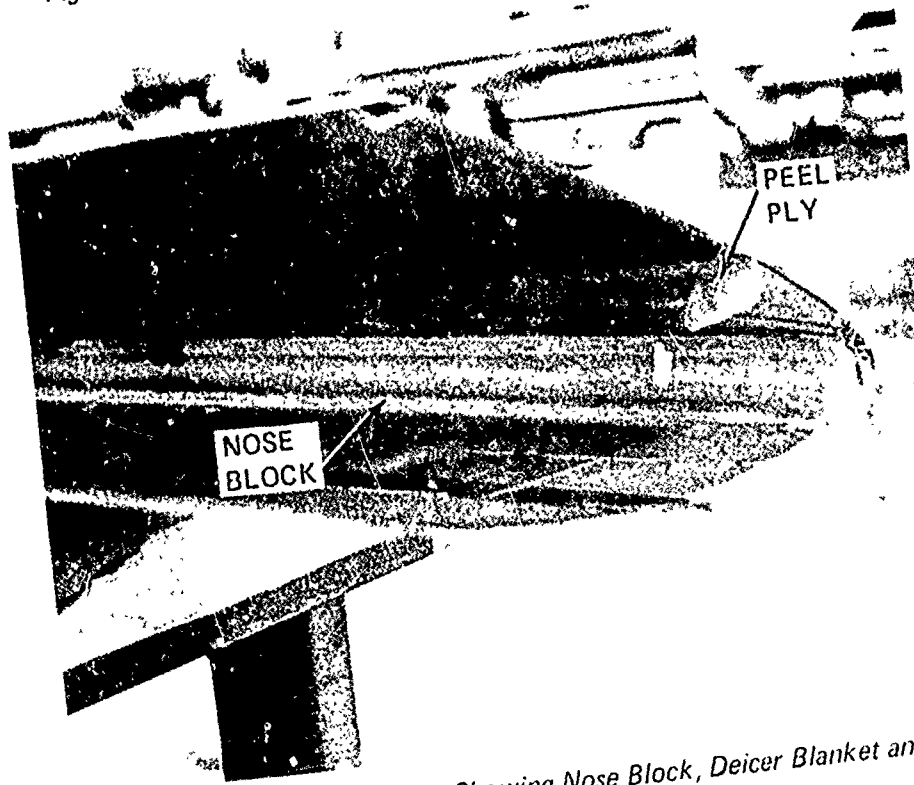
Figure 71. Warpage Test Article - Showing Nose Block, Deicer Blanket and Peel Ply

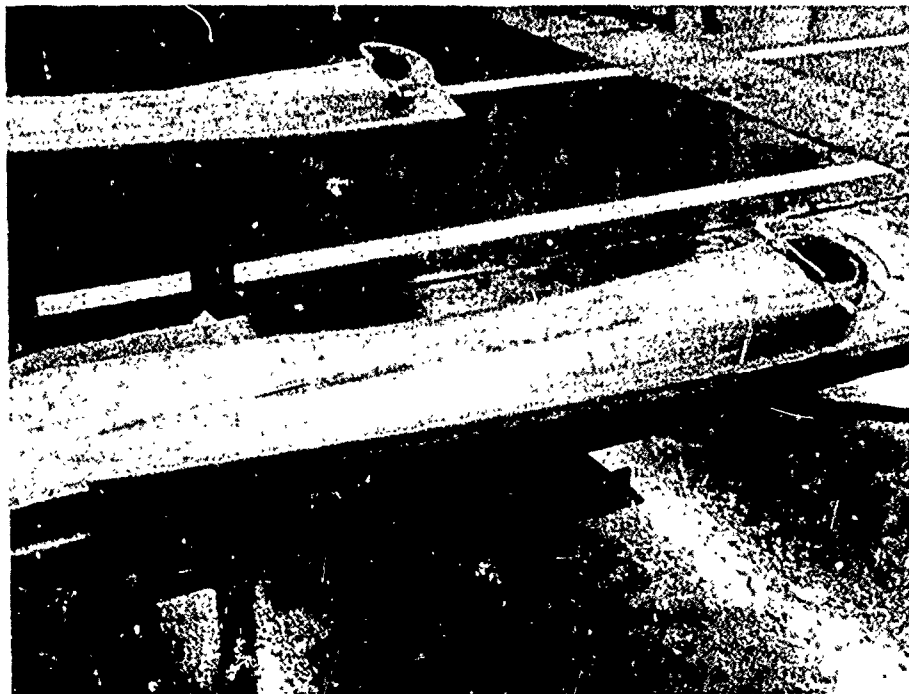
*Figure 72. Completed Spar Strap Subassembly*

The spar strap design was developed with the concept in mind of eventually making the transition to automated tape lay-up during production. A strap subassembly consists of the inner strap, outer strap, uni-directional fiberglass wedge, wraparound strap, and the inboard torsional wrap. (Refer to Figure 72.)

There are four strap subassemblies on each spar: one upper forward, one upper aft, one lower forward, and one lower aft. Each subassembly is laid up separately on its own lay-up mandrel. The task begins by locating the tooling expander on the inboard end of the lay-up mandrel. The inboard inner torsional glass cross-ply is positioned over this; then, the wrap-around strap detail is positioned against the tool expander

and over the cross-ply. At that point, lay-up of the inner strap is made, one ply at a time, with each ply extending farther outboard than the previous ply. The outer strap is then laid up until the plies finally extend to the blade tip end. In the process of laying up the outer strap, the uni-directional fiberglass wedge is positioned between the straps at the point where they converge.

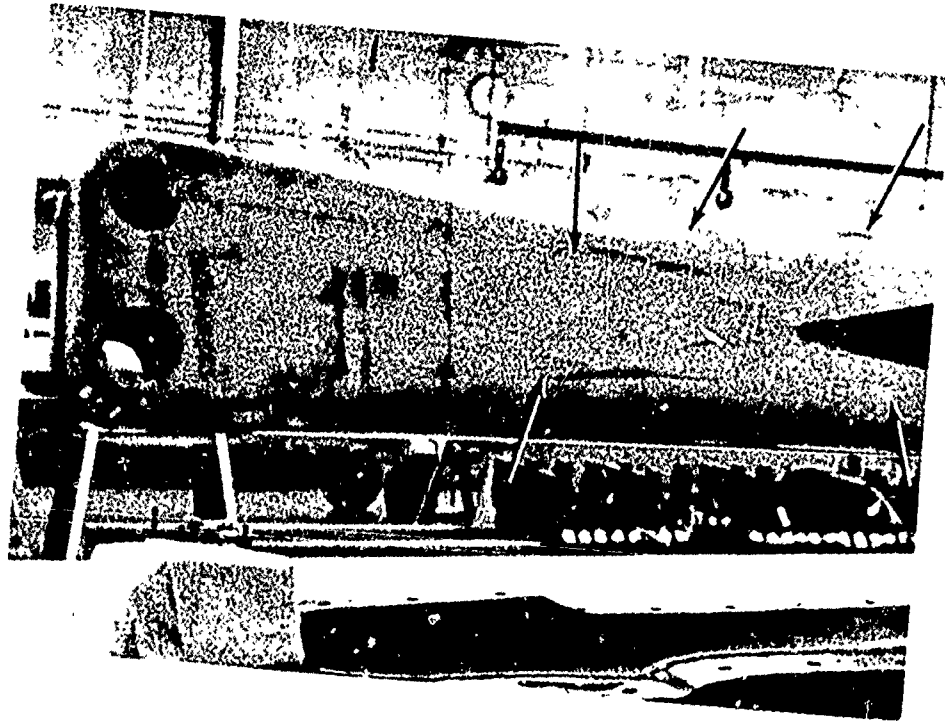
*Figure 73 . Root End Shank Wrinkles*

On spar number 3, shank wrinkling was encountered, and a portion of the wrinkle was attributed to inadequate control and placement of the tape lay-up through the transition area. Shank wrinkling is shown in Figure 73. An extensive effort placed on preventing further shank wrinkles by reducing bag mandrel size and tighter wrapping of outer cross ply material was successful. Tight monitoring of the strap lay-up process, coupled with a revised unidirectional wedge configuration, made a significant improvement in the quality of the spar straps produced.

**Spar Shank Wrinkling.** On ATC spar number 3, excessive wrinkling in the shank was identified after the spar was cured. This condition was considered to be unacceptable and had to be eliminated. An investigation was launched and corrective measures were identified. At that time, spar number 4, nearly assembled, was reworked to add an interim fix. The straps were realigned to

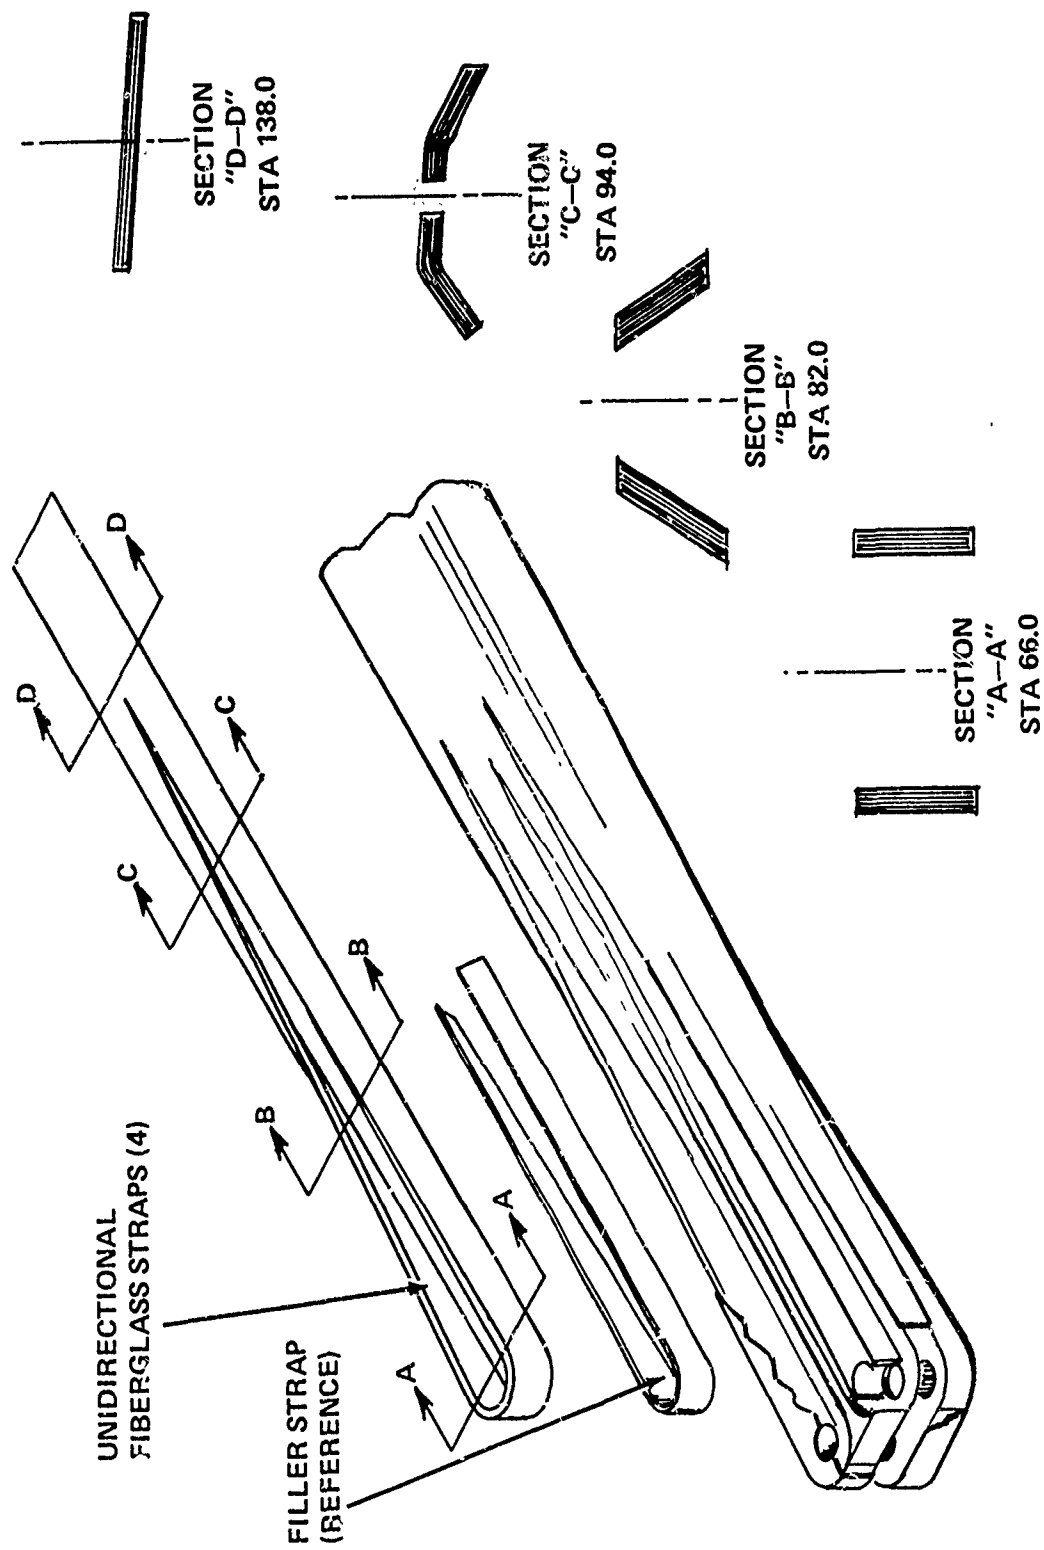
Figure 74. Typical Spar Strap Orientation

Figure 74 shows one of the four spar straps used in the spar assembly. The sections depict the way the strap starts in a horizontal position at the tip end (Station 552.0), continues at this attitude to approximately Station 138.0, and then rotates 90° to a vertical position at Station 66.0. There it reverses and returns to the tip end of the spar. (Refer to Engineering Drawing 301-11173, Sheet 3 in Appendix B.) During the cure of the spar, the internal mandrel (pressure bag) 3LM-SK301-11173-1 (see Figures 31 and 32) applies the required pressure to the strap. A special tool was required in the root end area (Stations 66.0 to 104.0 approx.) where the strap goes through the major change from horizontal to vertical. This tool (9MIT-SK301-11173-1) was designed using an inner wedge which, when activated by the internal mandrel, applies pressure to the spar strap (see Figure 75). The inboard end of the 9MIT-SK301-11173-1 mandrel is also activated by the inner wedge by expanding the serrated end of the tool (see Figure 76).

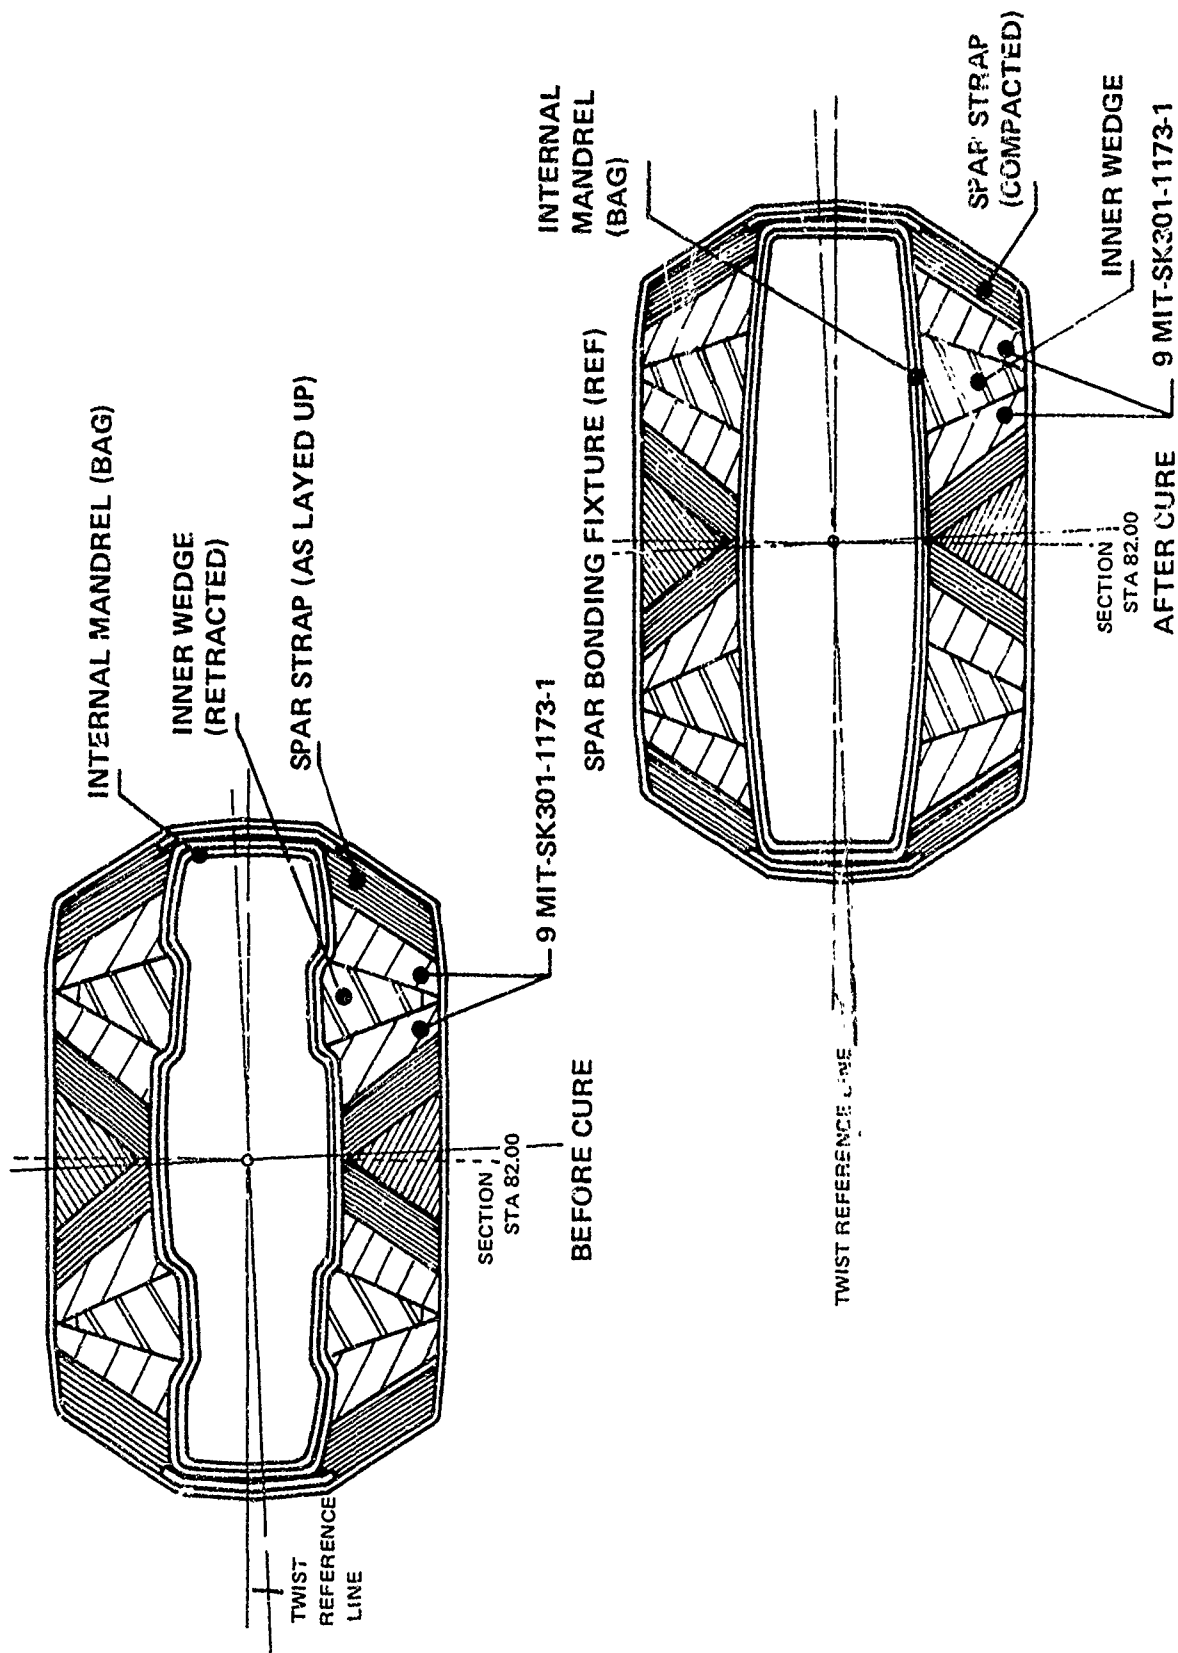
Figure 75. Root End Compaction, Station 66 to Station 109

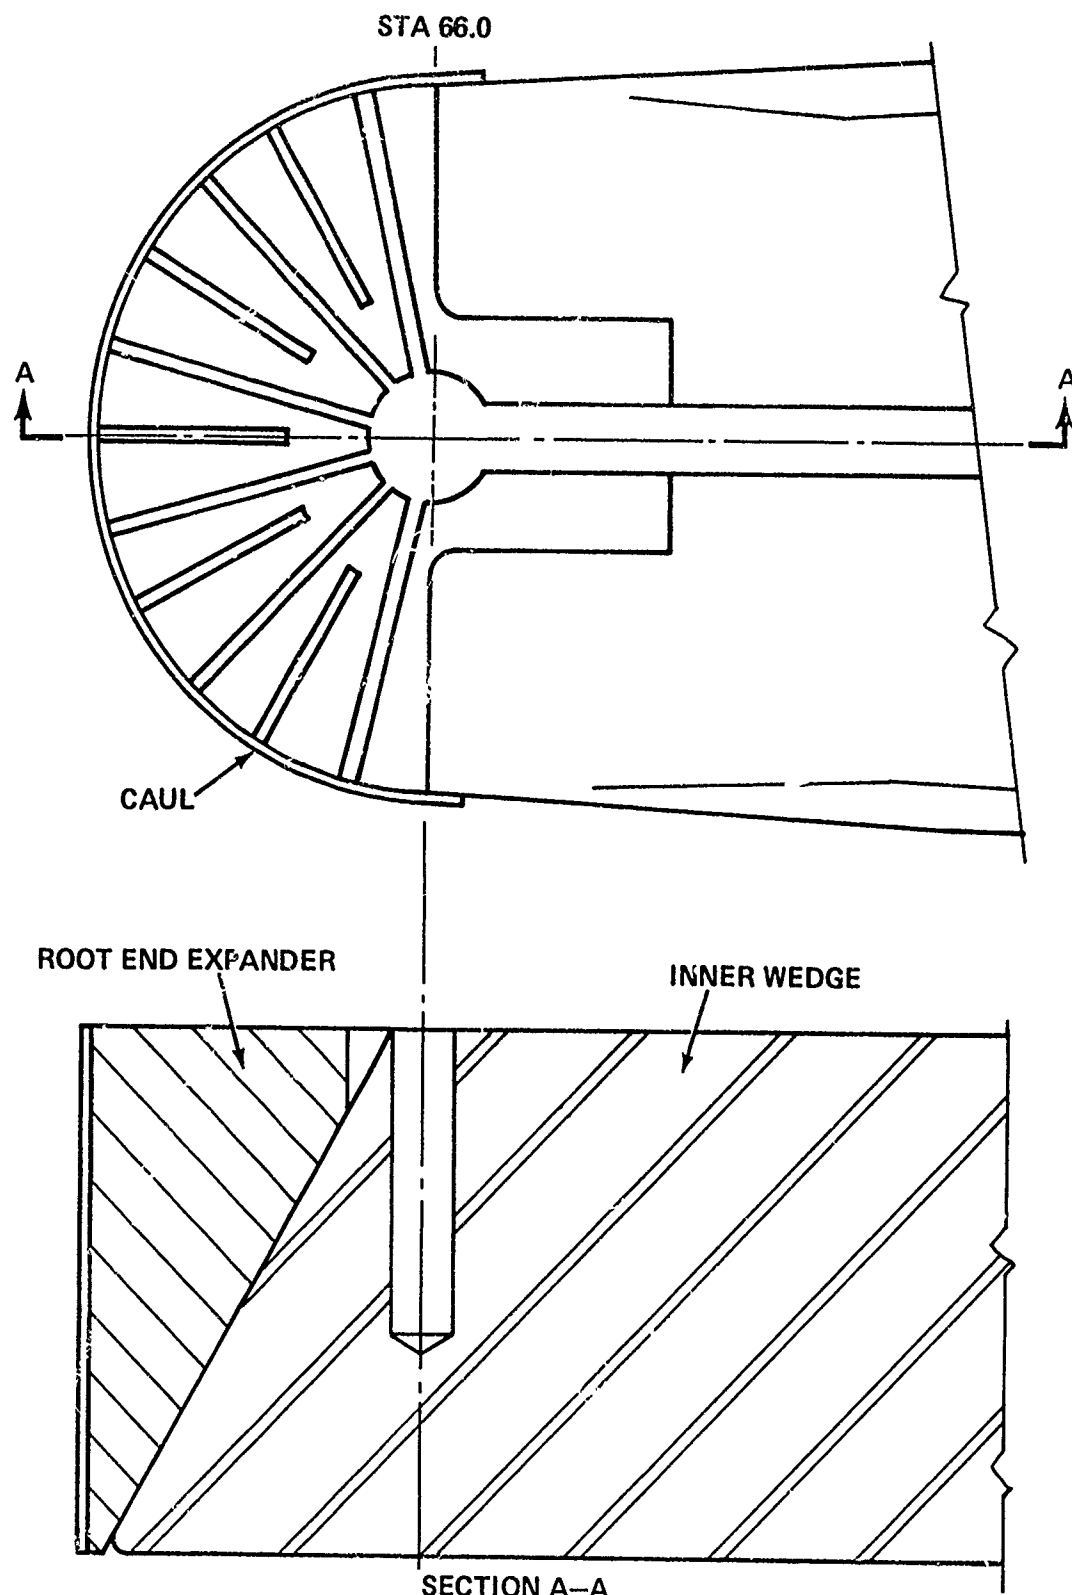
Figure 76. Root End Compaction, Station 66 Inboard

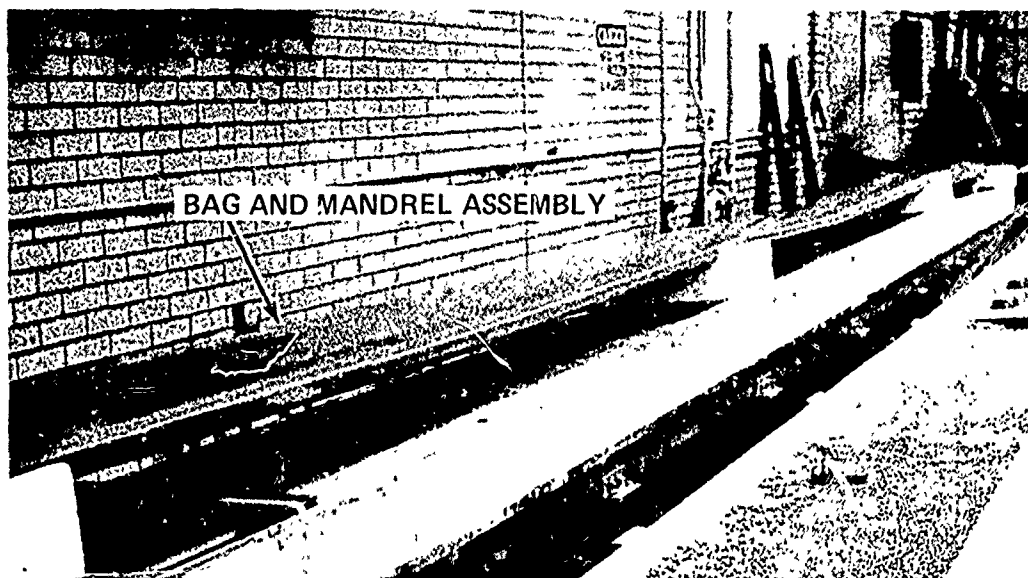
Figure 77. Bag and Mandrel Assembly Prepared for Assembly Stand

A good example of a successful program was the spar bag and mandrel development. Economics dictated the requirement for a redundant bag, since a bag failure could necessitate scrapping the entire spar. The "D" spar configuration added complexity because the assembly function required a firm mandrel that could be removed after curing. Handling of the uncured spar placed even greater demands on the design. The bag and mandrel were required to be sufficiently rigid to accommodate movement and transfer. The final design included a laminated graphite/honeycomb strong-back as the structural member within the mandrel (Figure 77). The development of the bag and mandrel assembly is described in the tooling section of this report.

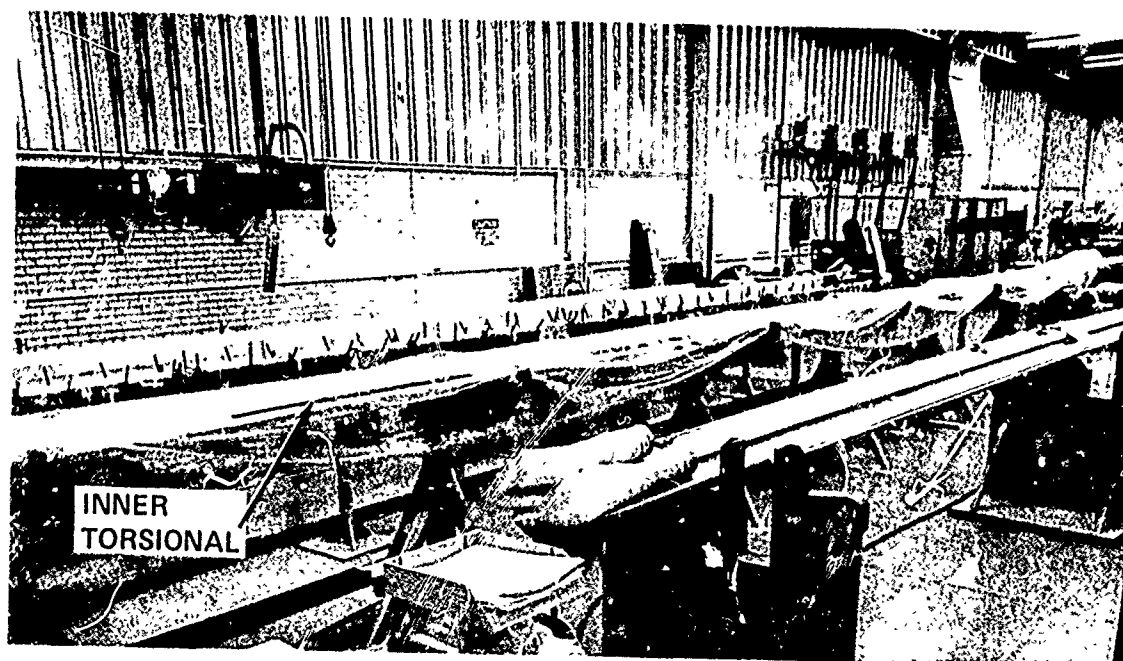
*Figure 79. Spar No. 1 with Inner Torsional Skin Lay-Up on Bag Mandrel*

The spar fabrication involves the assembly of details on a bag and mandrel, installation of the leading edge assembly, and the curing operation. The process begins by positioning the bag and mandrel on the 8MIT assembly stand. (Refer to Figures 33 and 78.) The upper end inner torsional skin is then laid up on the bag (Figure 79), followed by the unidirectional stiffener graphite. On top of this, the strap subassemblies are positioned together with the "T" bone fillers and leading edge filler (Figure 80). The assembly is then flipped over, and the same operations are repeated for the opposite (lower) side. At that time, the outer torsional wrap is positioned over the lower side lay-up. The assembly is then flipped over once more, and the upper outer torsional wrap is applied (Figure 81) and tied in with the lower half. Following this operation, the spar is positioned on its heel, and a sheet of adhesive is draped over the entire unit. The leading edge assembly is next

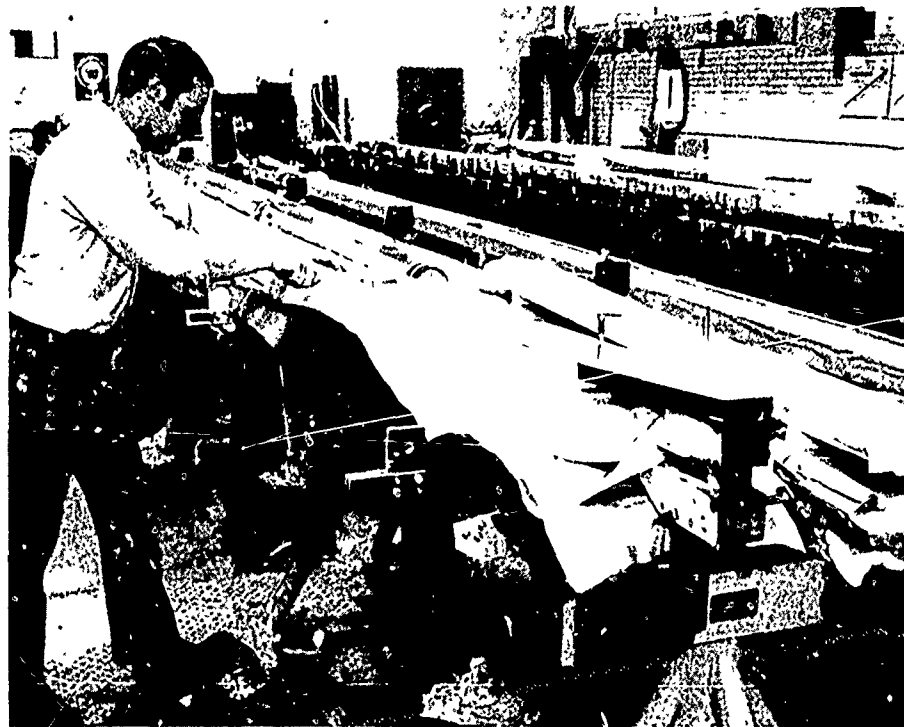
*Figure 80. Spar Assembly Stand Showing Spar Strap Subassemblies Positioned on Inner Torsional Wrap*

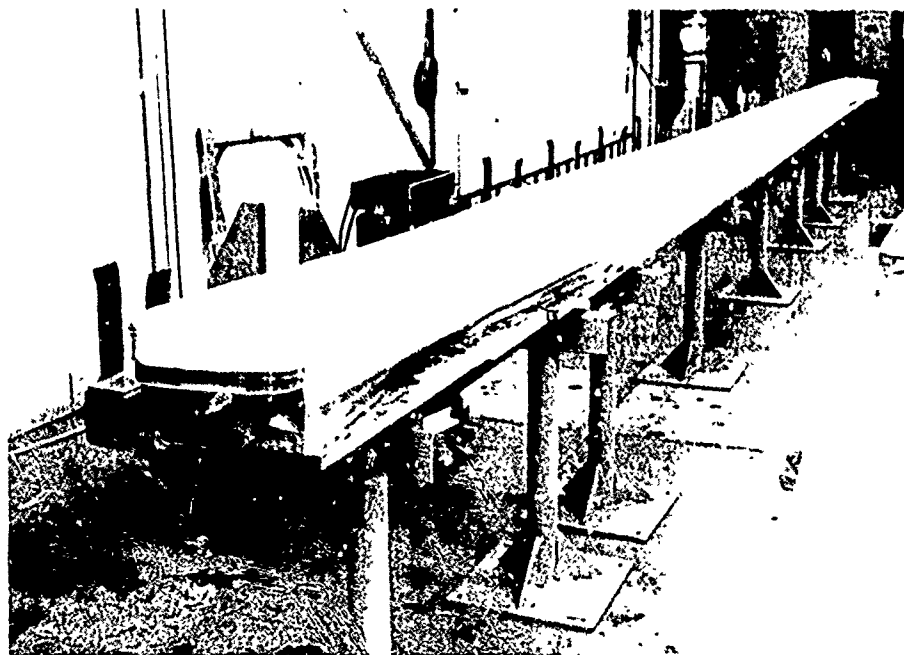
*Figure 81. Outer Torsion Wrap Ready for Installation*

Other items identified as requiring improvement were the method of fabrication and the handling of the outer torsional wrap. The spar bonding fixture was used for lay-up of the outer torsional wrap on spar number 1. The operation was slow and tedious and represented a program constraint since the fixture was also required for other blade operations. As a result, two new tools were fabricated to provide a male lay-up mandrel (Figure 87). After the tools were built and used (in spar number 3 and all succeeding spars), the lay-up task was improved, and transfer of the outer torsional wrap from the tool to the spar was simplified.

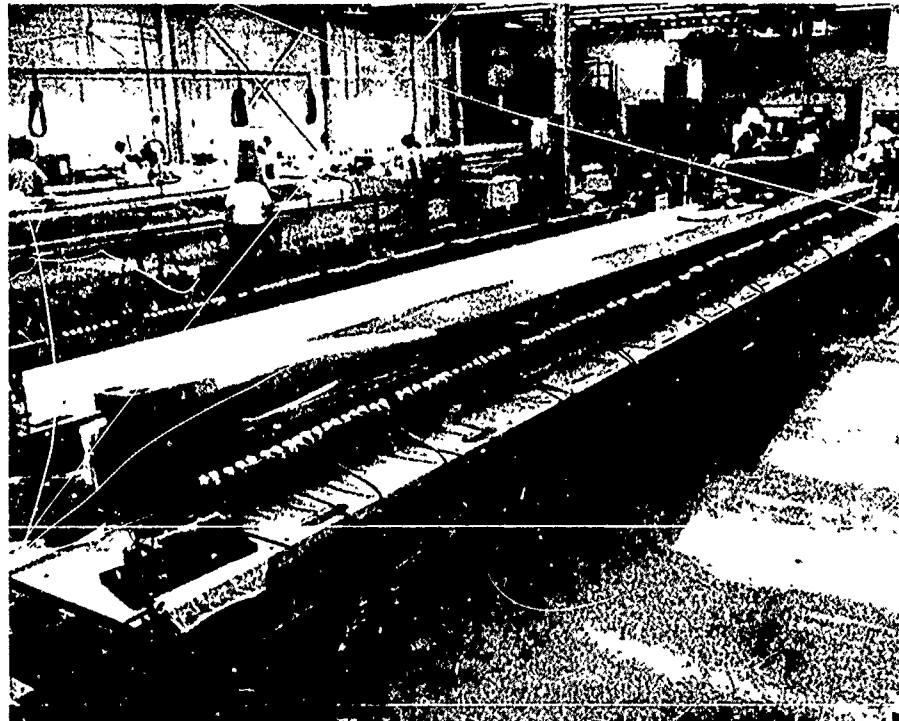
Figure 83. Ready to Unload Spar No. 1 After Curing Operation

positioned over the spar and secured. Then the assembled spar is turned on its side, and the adhesive is trimmed. The spar bonding fixture (lower half) is installed on an air table and moved alongside the spar assembly stand. The spar is prepared for transfer and is lifted up and placed into the bonding fixture. The bonding fixture and spar are then transferred to the Universal restraining base, where the upper molds are positioned and bolts are installed (Figure 82). Finally, the tool root and tip ends are closed, the hoods are installed, and the curing operations are begun. (Refer to Figures 83 and 84).

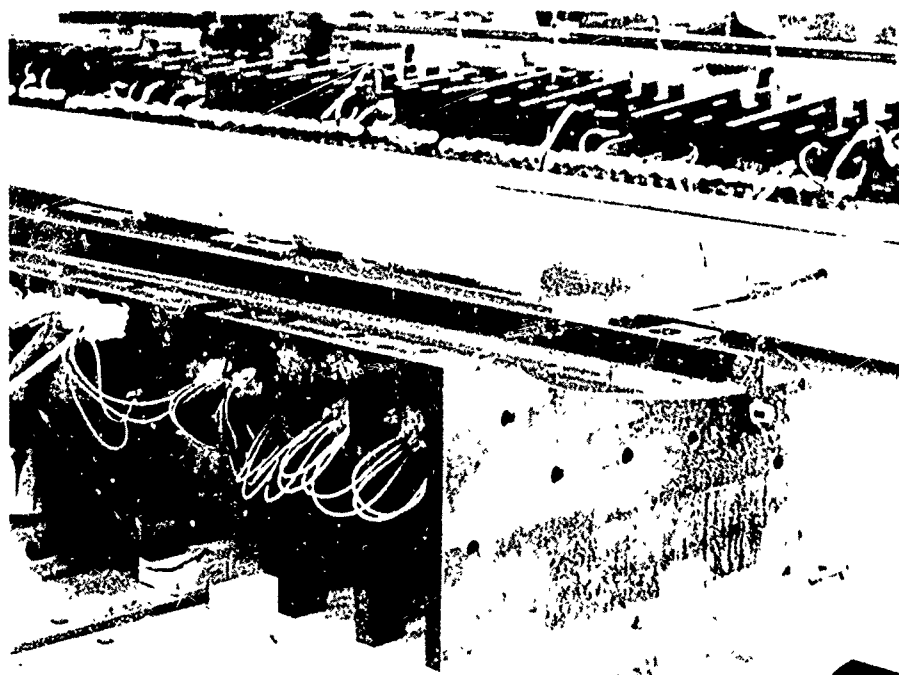
Figure 84. Spar No. 1 - Tip End View Showing Thermocouple Wiring

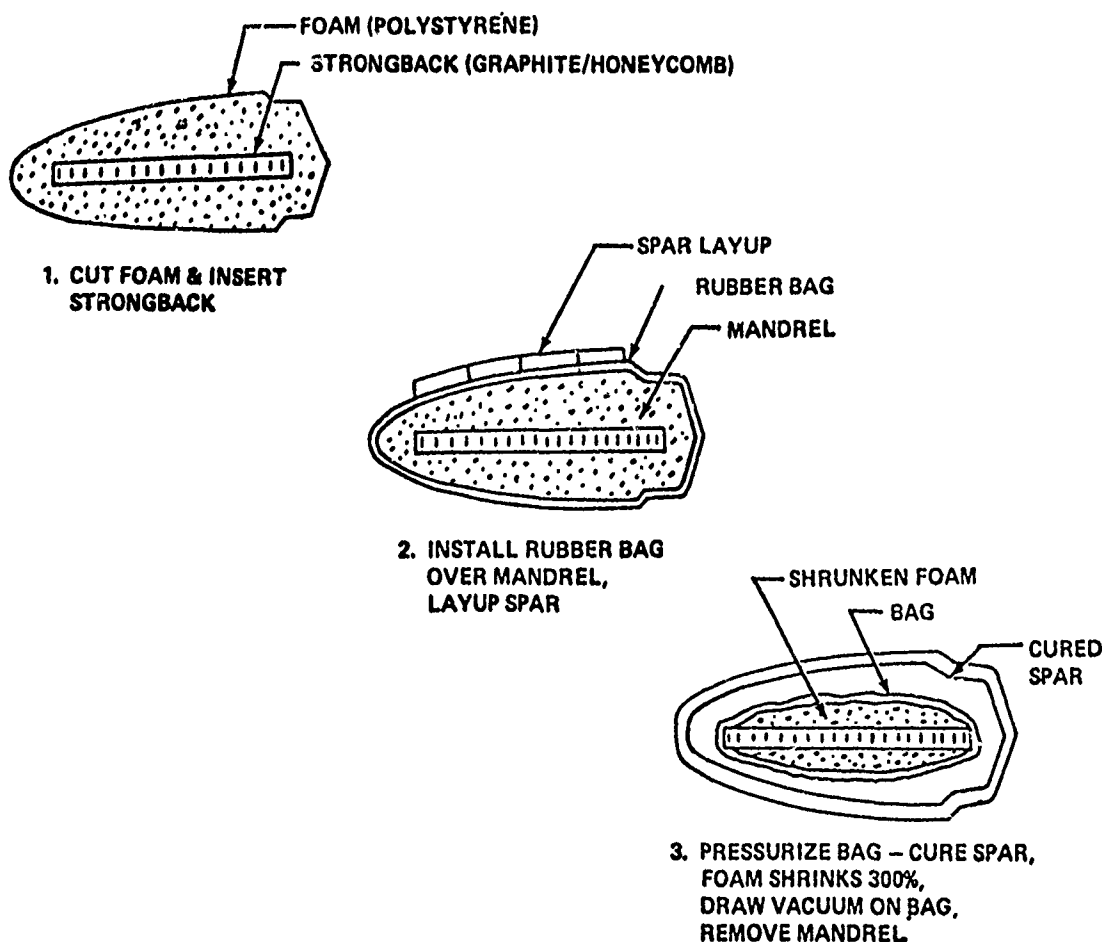
Figure 85. Foam Mandrel Concept and Bag Removal

Bag Damage During Removal. The bag (and mandrel) is removed from the cured spar while the spar is still supported in the lower half of the bonding fixture. The first item to be removed is the "strongback" which, being a flat plane (no twist) and a constant width, is easily removed from the tip end of the spar. The foam, having been shrunk by the 250° heat during the cure cycle (see Figure 85), fits through the small aperture at the tip end. It should be noted that during the assembly of the mandrel strips of nylon were bonded to the foam sections, which assists in the removal operation. The rubber bags are the last to be removed, and this is accomplished by first relieving the outer bag from the spar I.M.L. The outer bag, having been completely covered with teflon tape, is easily released; however, the friction must be broken, and this is done by inserting a long wedge (wood board) in the tip end between the bag and spar. This is repeated until the complete bag is free from the spar. The bag is then extracted from the tip end of the spar. As a precaution after the bags are removed, the teflon tape is removed from the outer bag and both bags are pressure checked and inspected for any damage (cuts, holes, etc.) and repaired as required before reusing. On the first spar, the redundant bag was extensively damaged during removal. The bag and mandrel development program included a bag removal operation on a short simulated spar. The general technique for removal was identified and was considered satisfactory. However, on a full length spar, the bag removal operation proved to be more difficult than originally envisioned.

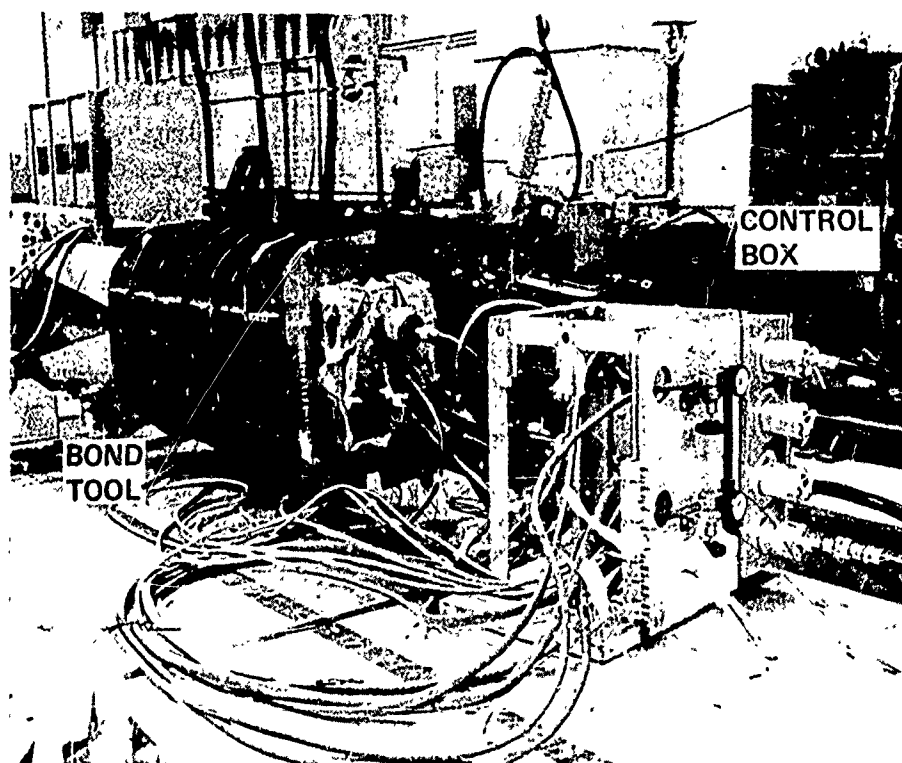
Figure 87. Spar No. 1 Showing Bond Tools in Use for Closure Fitting ,11204) Bond

The root end fittings include the four closures which nest on the IML just forward of the pin holes. Early attempts to hot-bond these fittings were not successful, and the design was changed to a cold-bond adhesive. The configuration dictated that heat for hot bonding had to be driven through the fitting or spar into the bondline (Figure 87). The large mass in that area precluded this approach. The cold bond adhesive was incorporated and proved to be very successful when tested. As a result, the blade (number 1) that was hot bonded was modified using the cold bond adhesive. As a part of the design-to-cost program, the closure fitting design and fabrication is being studied. To eliminate the high cost of fit-up and bond, the "co-cure" approach has been selected for the prototype aircraft. The fitting becomes a "B" staged, semi-cured preform, which is cured during the spar cure. A sample fitting has been laid up and "B" staged with excellent results.

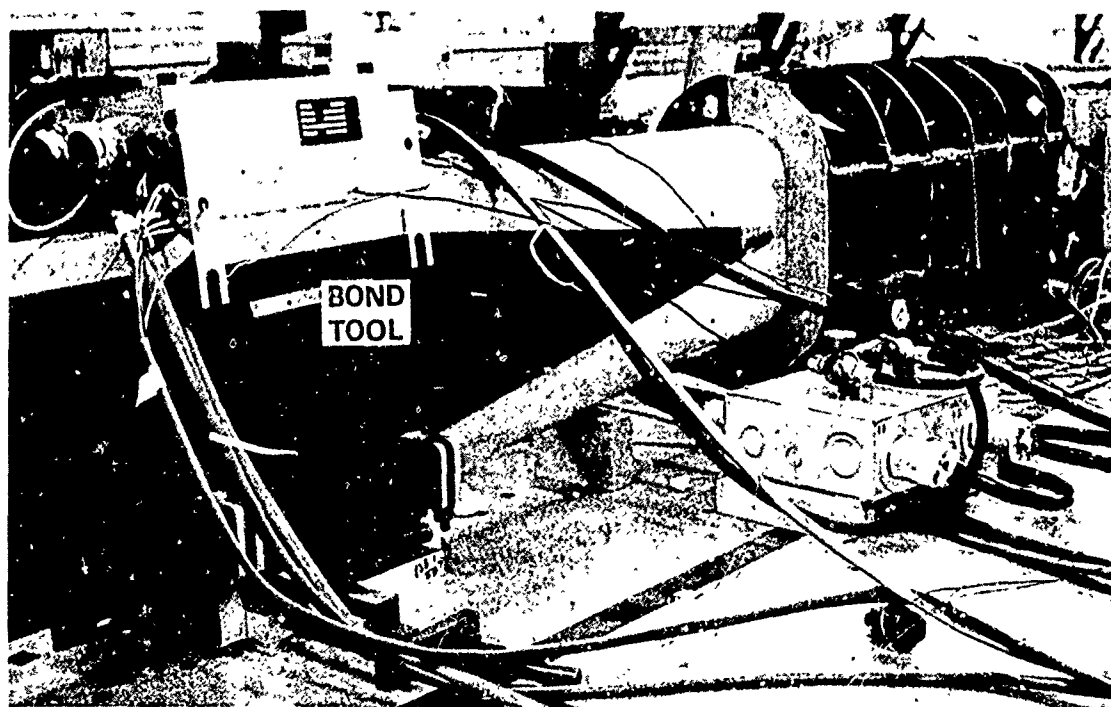
Figure 88. Spar No. 1 with Insert (11176) Bonding Tool Being Used

The other root end fittings are the two inserts located at Station 139, where the fairing leading edge blends into the spar (Figure 88). A minimum of fit-up is required, and bonding represents few problems.

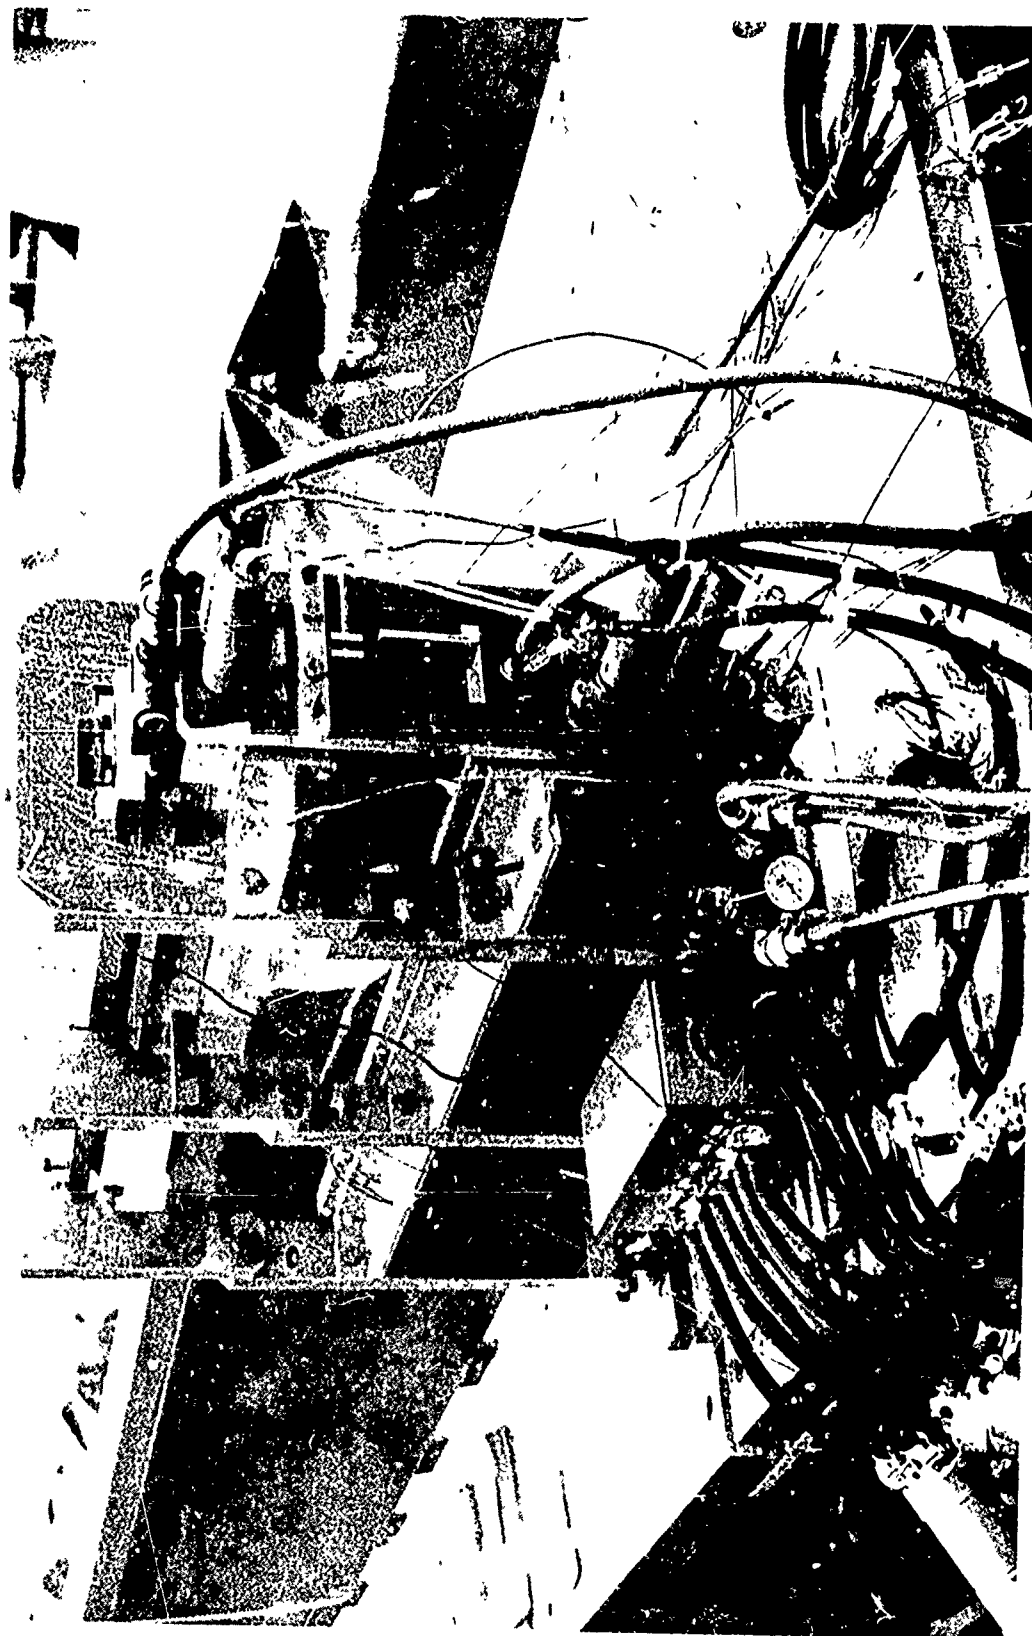
Figure 89. Tip Fittings Being Bonded to Spar

The other tip end fitting (aft weight) required a minor fit-up operation prior to being bonded to the spar. This bonding operation is also simple, with few problems. Both tip fittings are bonded to the spar concurrently to minimize flow time. (Refer to Figure 89.)

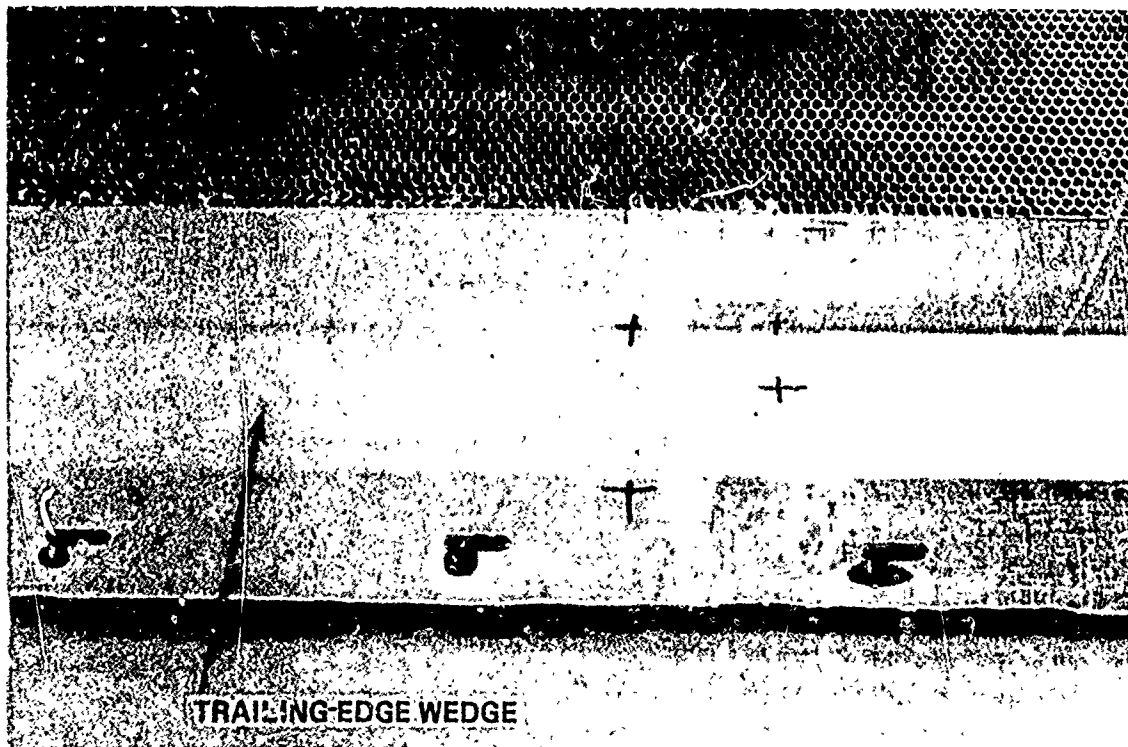
*Figure 90. Trailing-Edge Wedge Assembly After Bond to Core*

Wedge-to-Core Subassembly. The wedge-to-core subassembly involves positioning the trailing edge wedge with the honeycomb core blocks and adhesive in the fairing bond fixture (VFM). The core is Nomex honeycomb that has been purchased pre-cut to a specified size. A special nodal bond adhesive (Hexabond) is used on the core-to-core bond (between the three segments), and a foaming adhesive (FM 37) is used between the core and trailing edge wedge. The subassembly is bagged and cured in the autoclave. After curing, the subassembly is inspected in preparation for the next operation (Figure 90).
